ICF TECHNOLOGY INCORPORATED

DATE: October 19, 1993

REF: ARCS Contract No. 68-W9-0025
Work Assignment No. 35-6JZZ

SUBJ: Site Inspection Prioritization
Pine Bluff Arsenal, Pine Bluff, Jefferson County, Arkansas
CERCLIS #AR0213370707

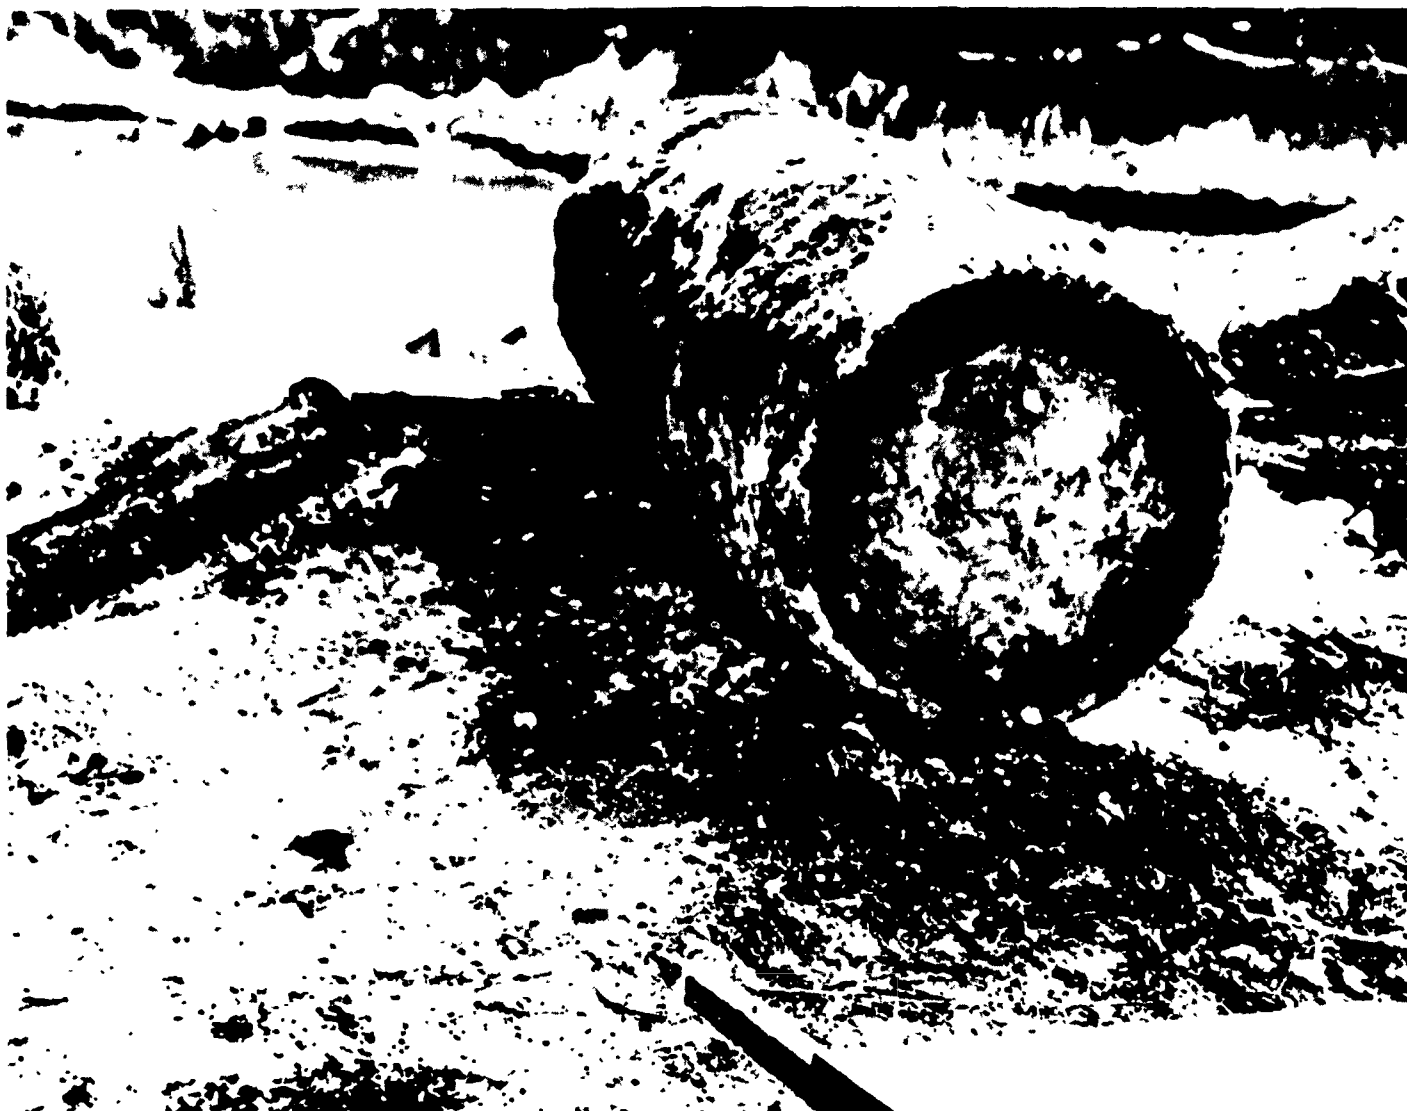
B-14

LEAKING M70 LEWISITE FILLED BOMBS. (28 APRIL 55)
